## Value Managed Failure Analysis and Product/Process Improvement

James R. Wixson, CVS, Staff Engineer  
Lockheed-Martin Idaho Technologies, Inc.  
Idaho Falls, Idaho

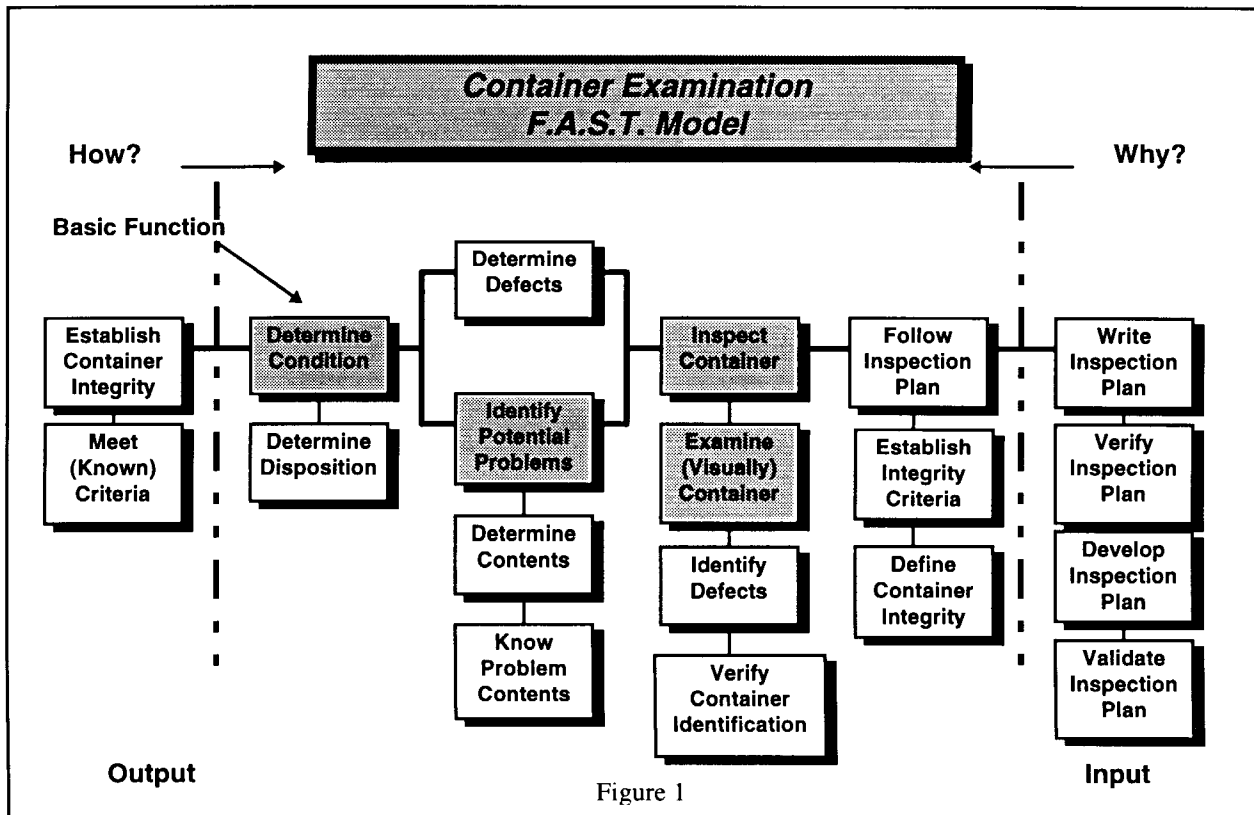
Figure 1 illustrates the FAST Model the team developed which helped isolate the functions that were contributing to the inadequacies of the inspection process. The shaded functions were those determined by the team contributing to the less than adequate performance of the basic function. Had time permitted, these functions would have also been evaluated to determine their potential causes of failure and what could be done to improve their performance. However, since time was very limited, it was decided that improving the performance of the basic function would be sufficient.

Once these questions were answered, a mission statement was developed which was key to the function analysis and FAST Modeling of the problem. This process also included a thorough root cause analysis of the basic function "determine condition".
